REPORT OF INVESTIGATION

Surface Nonmetal Mine
(Limestone)

Fatal Machinery Accident
September 7, 2007

Canarico Quarries
Canarico Quarries, Inc
Santa Isabel, Juana Diaz, Puerto Rico
Mine I.D. 54-00159

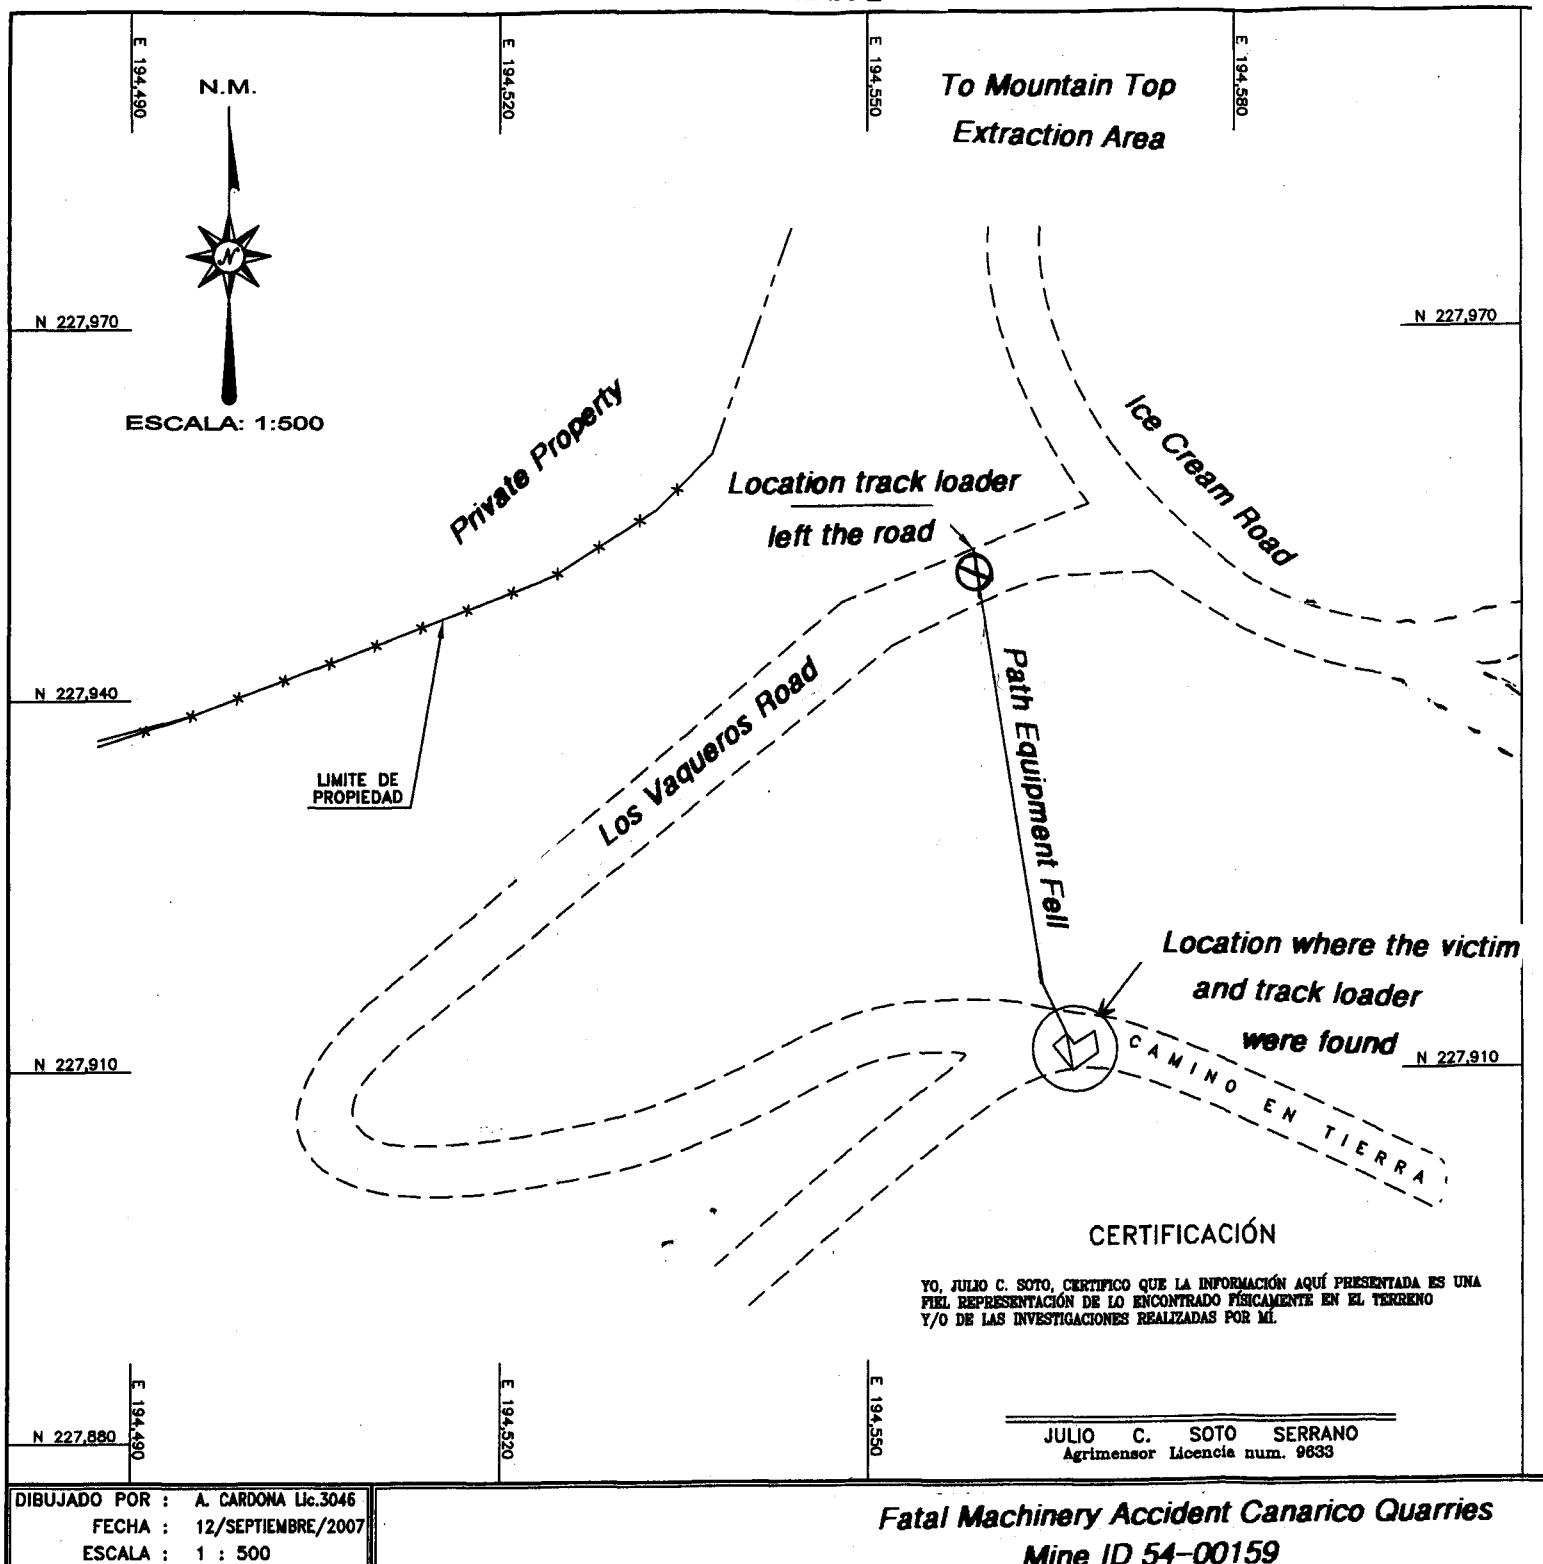
APPENDIX B

The accident occurred at a secondary road that was not frequently traveled. The victim was operating the track loader on the edge of the secondary road approximately 40 feet from the intersection of the access road. While the victim was operating the track loader, he came too close to the edge of the road, and lost control of the equipment. The track loader traveled approximately 120 feet down a 68% grade, and continued to travel another 15 feet onto the lower section of the secondary road which spiraled down the mountain.
